**TOPIC:** THIRD AND HETHERTON TRAFFIC STUDY

**SUBJECT:** INFORMATIONAL REPORT ON THE THIRD AND HETHERTON  
TRAFFIC STUDY

## Third and Hetherton Traffic Study Final Report | June 2018

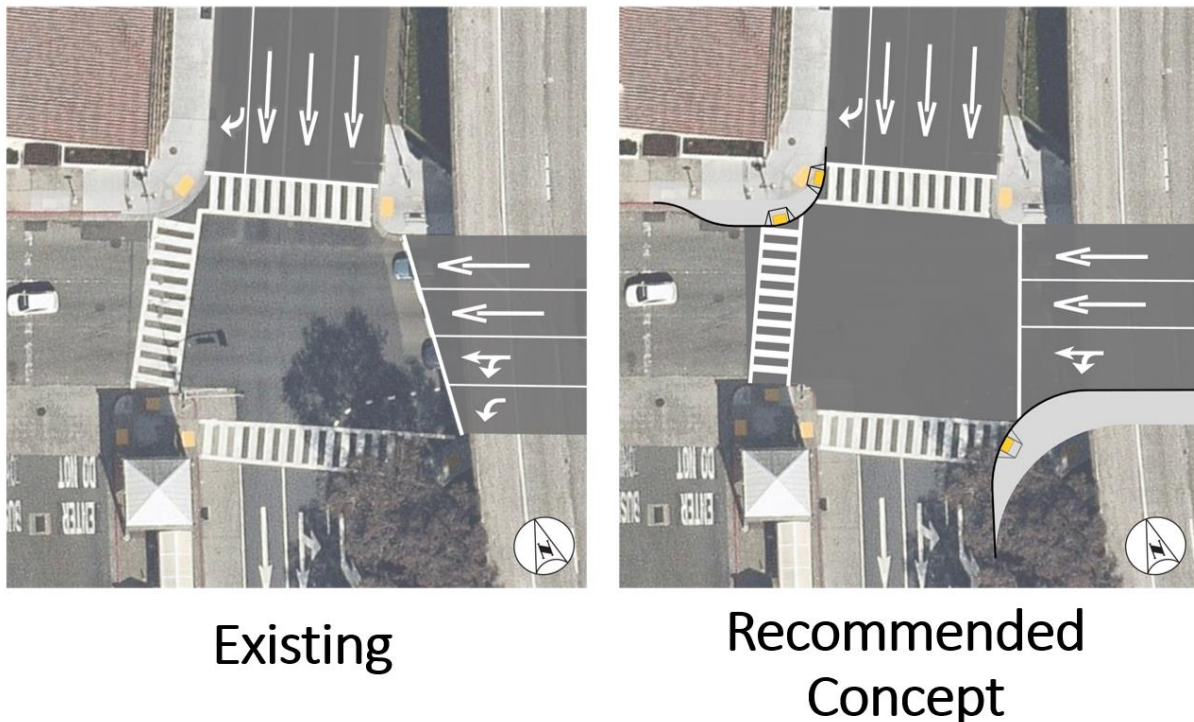
**Figure 1: Recommended Concept**

The recommended concept improves pedestrian safety by eliminating the double left turn from Third Street and reduces the crossing distance of the south and west crosswalks. This concept also includes a leading pedestrian interval (LPI) which provides a head start for pedestrians crossing. The current left turn pocket will be eliminated, leaving two thru lanes and a left/thru lane on Third Street. While eliminating this short existing turn pocket may seem like a significant impact, based on the traffic analysis this change will increase the delay at the intersection in the morning peak by 3 seconds and the evening peak by 2 seconds each which are not considered significant. The analysis assumes a five second LPI which is applied to the north and south

Based on completion of a traffic analysis, cost estimates of the conceptual designs, which ranged from \$200,000 to \$400,000, and an assessment of safety benefits for pedestrians, staff has a recommended concept to be considered as the preferred option for this intersection.

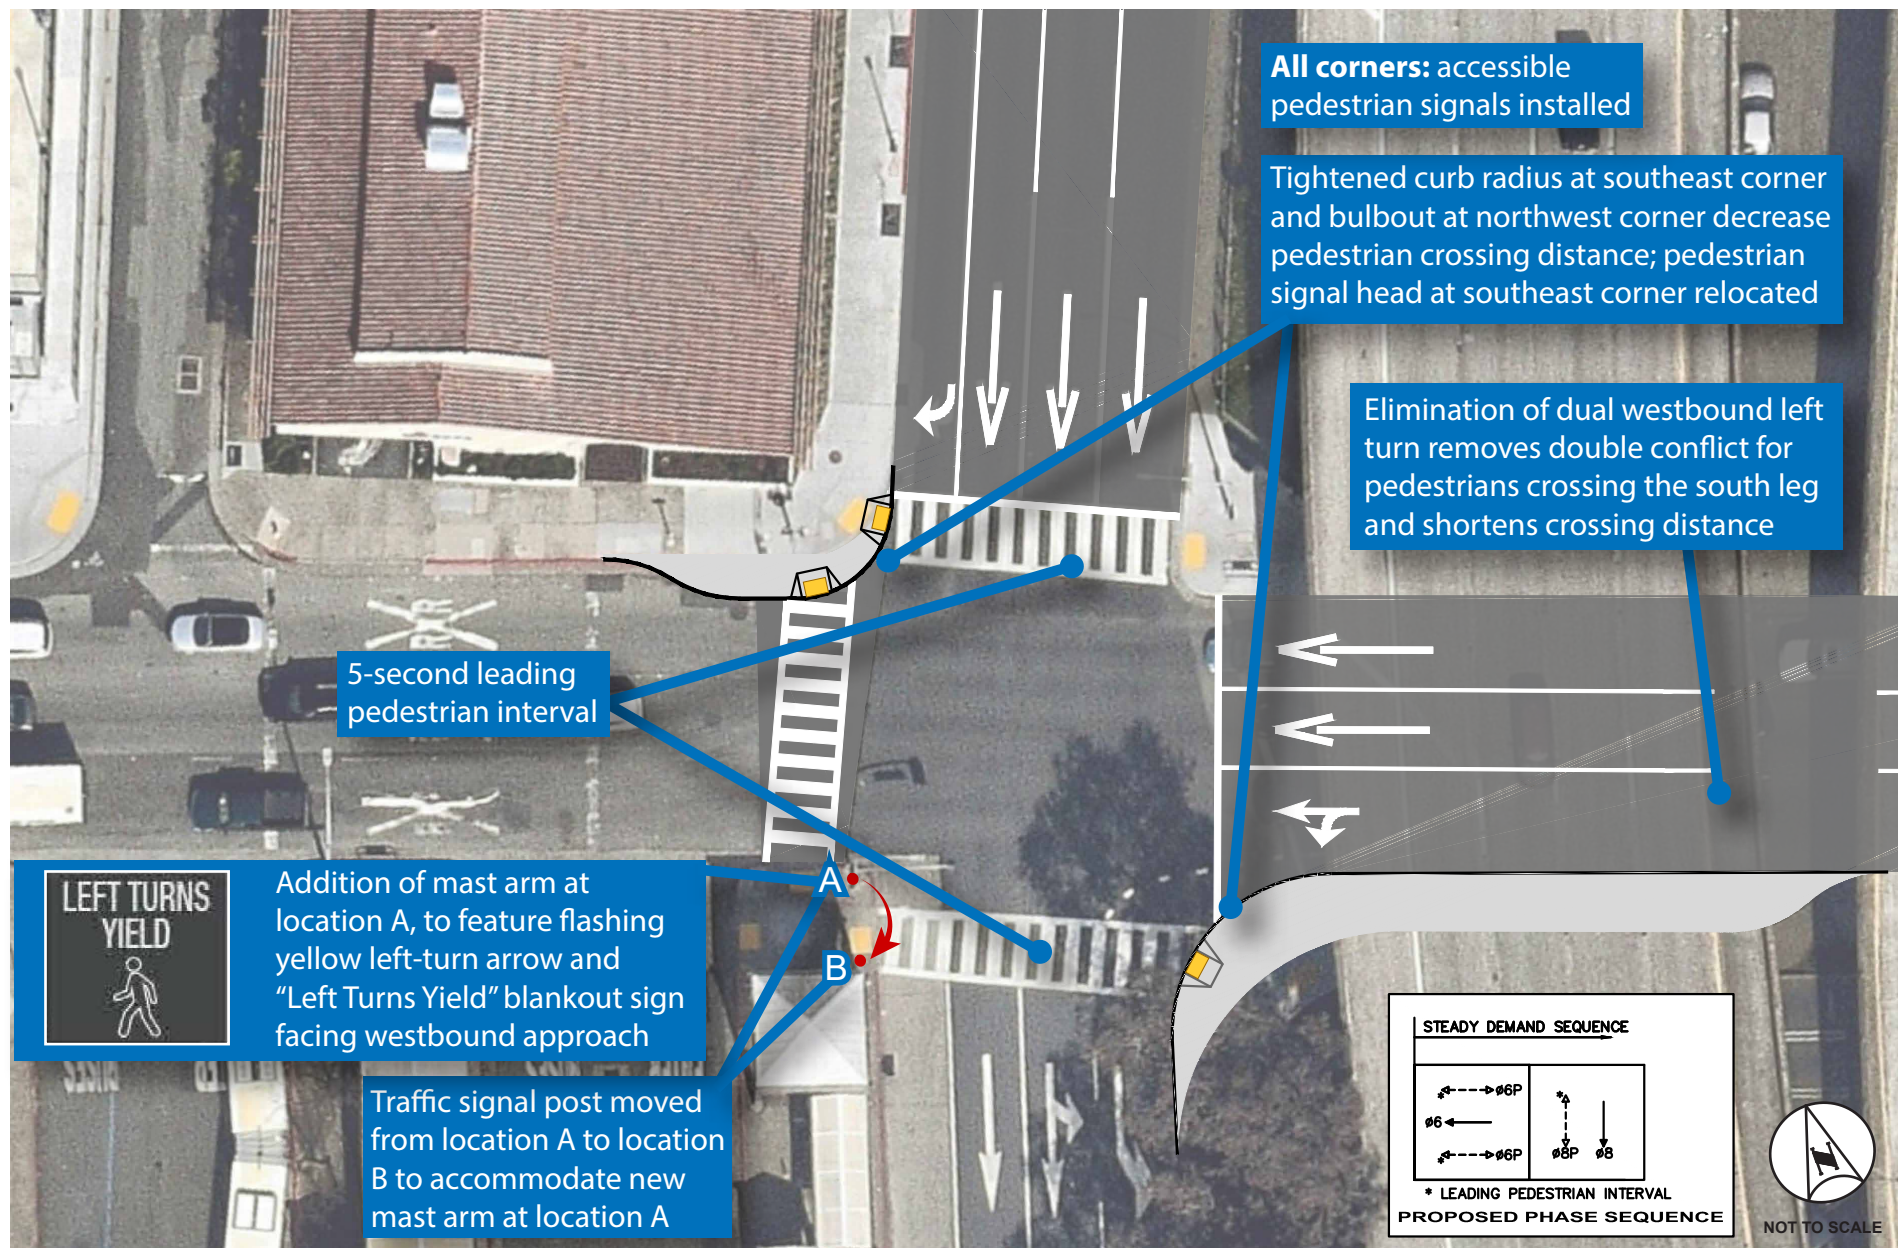
The recommended intersection concept, as depicted in **Figure E-1**, includes the following modifications to the study intersection:

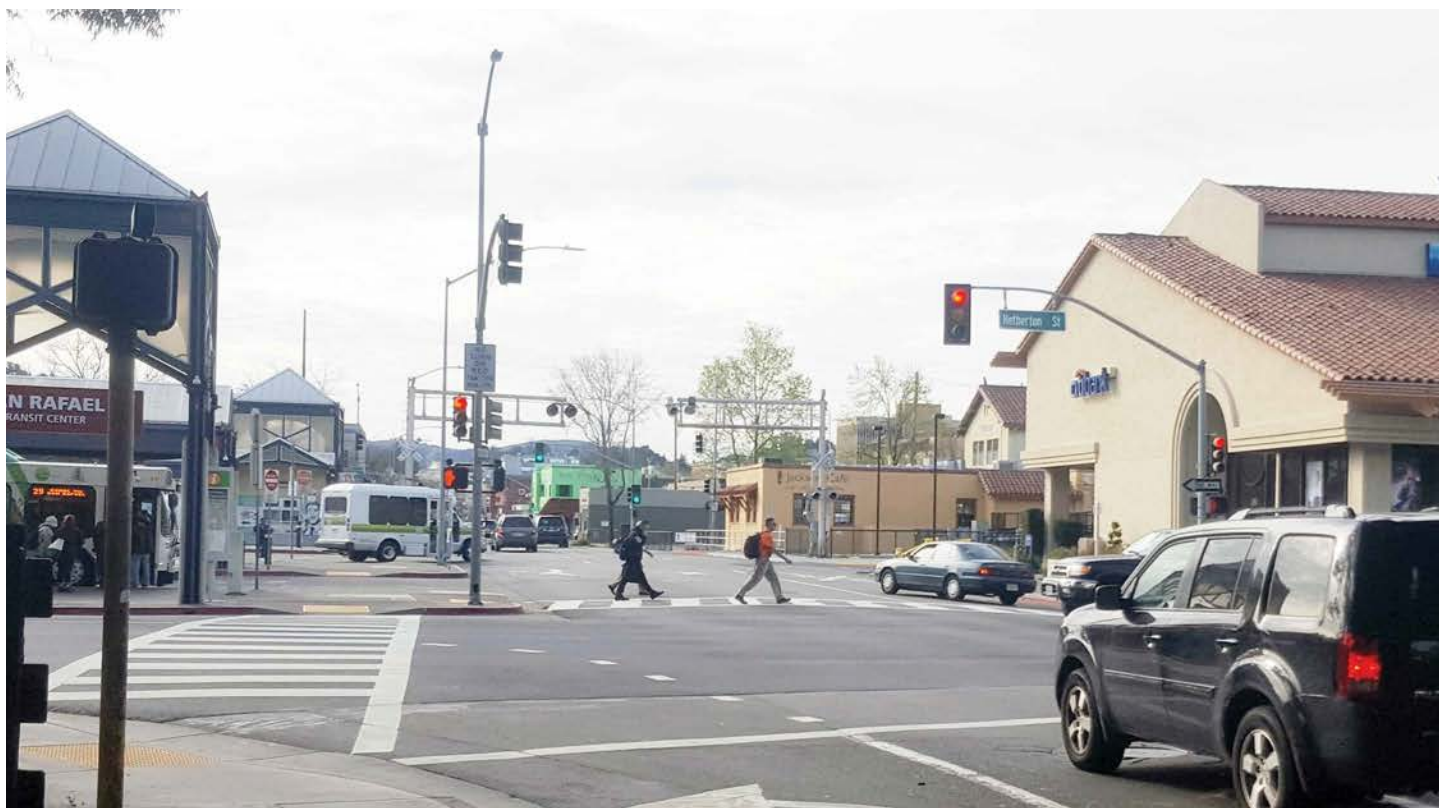
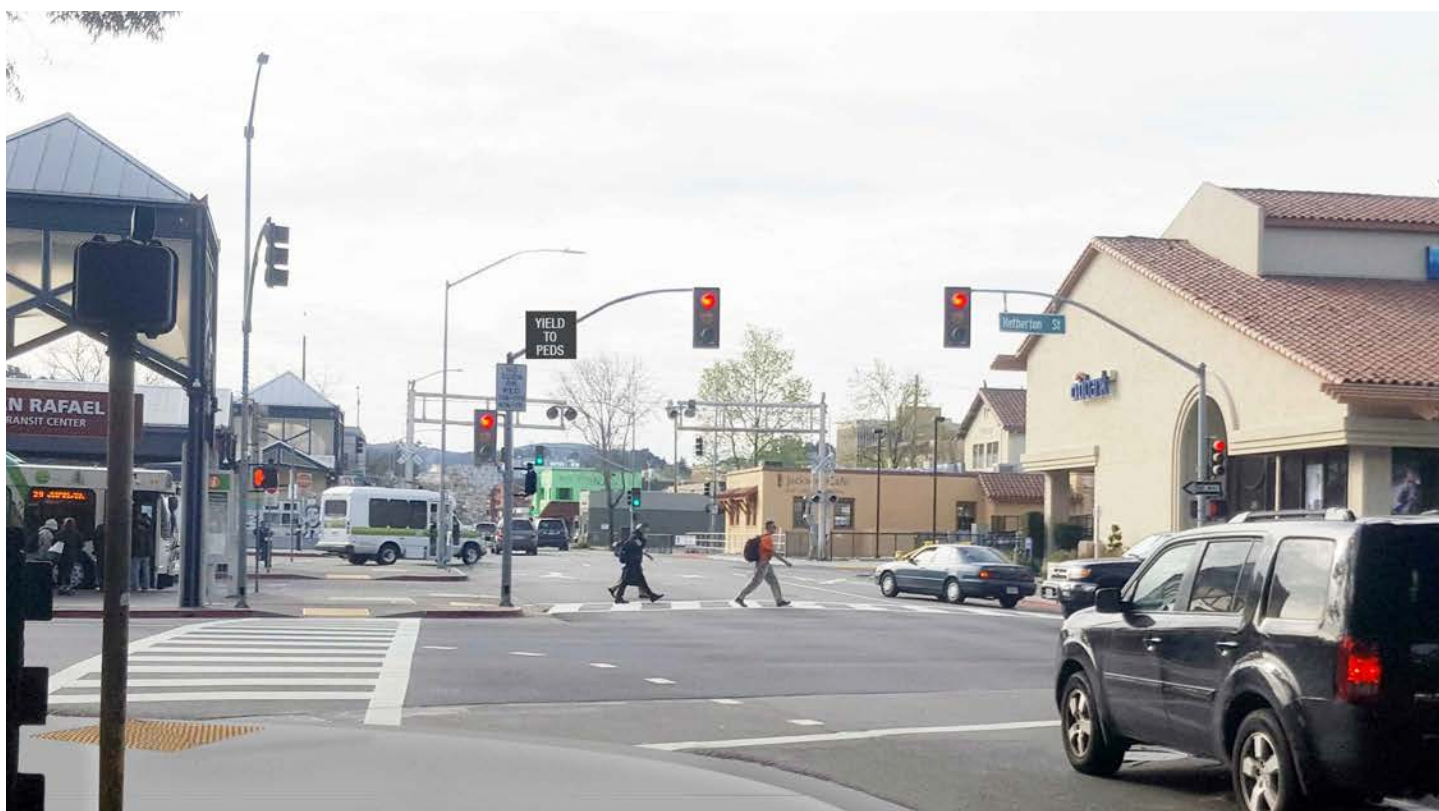
*Existing Conditions*

*With Improvements*

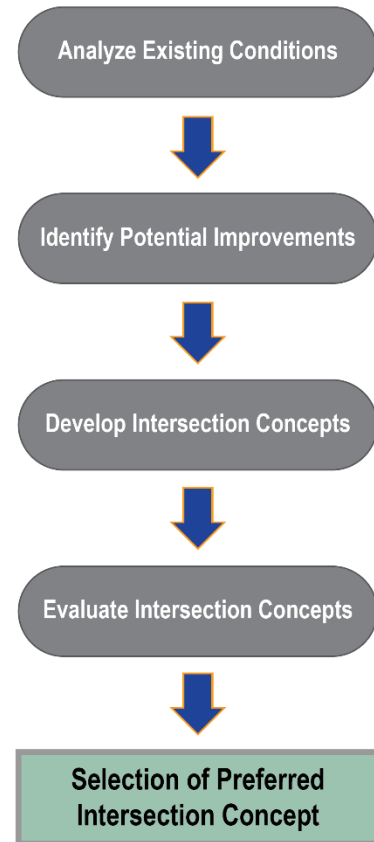
**Figure 1-2:** Project Flow Chart

The project was completed following the general process shown in **Figure 1-2**.

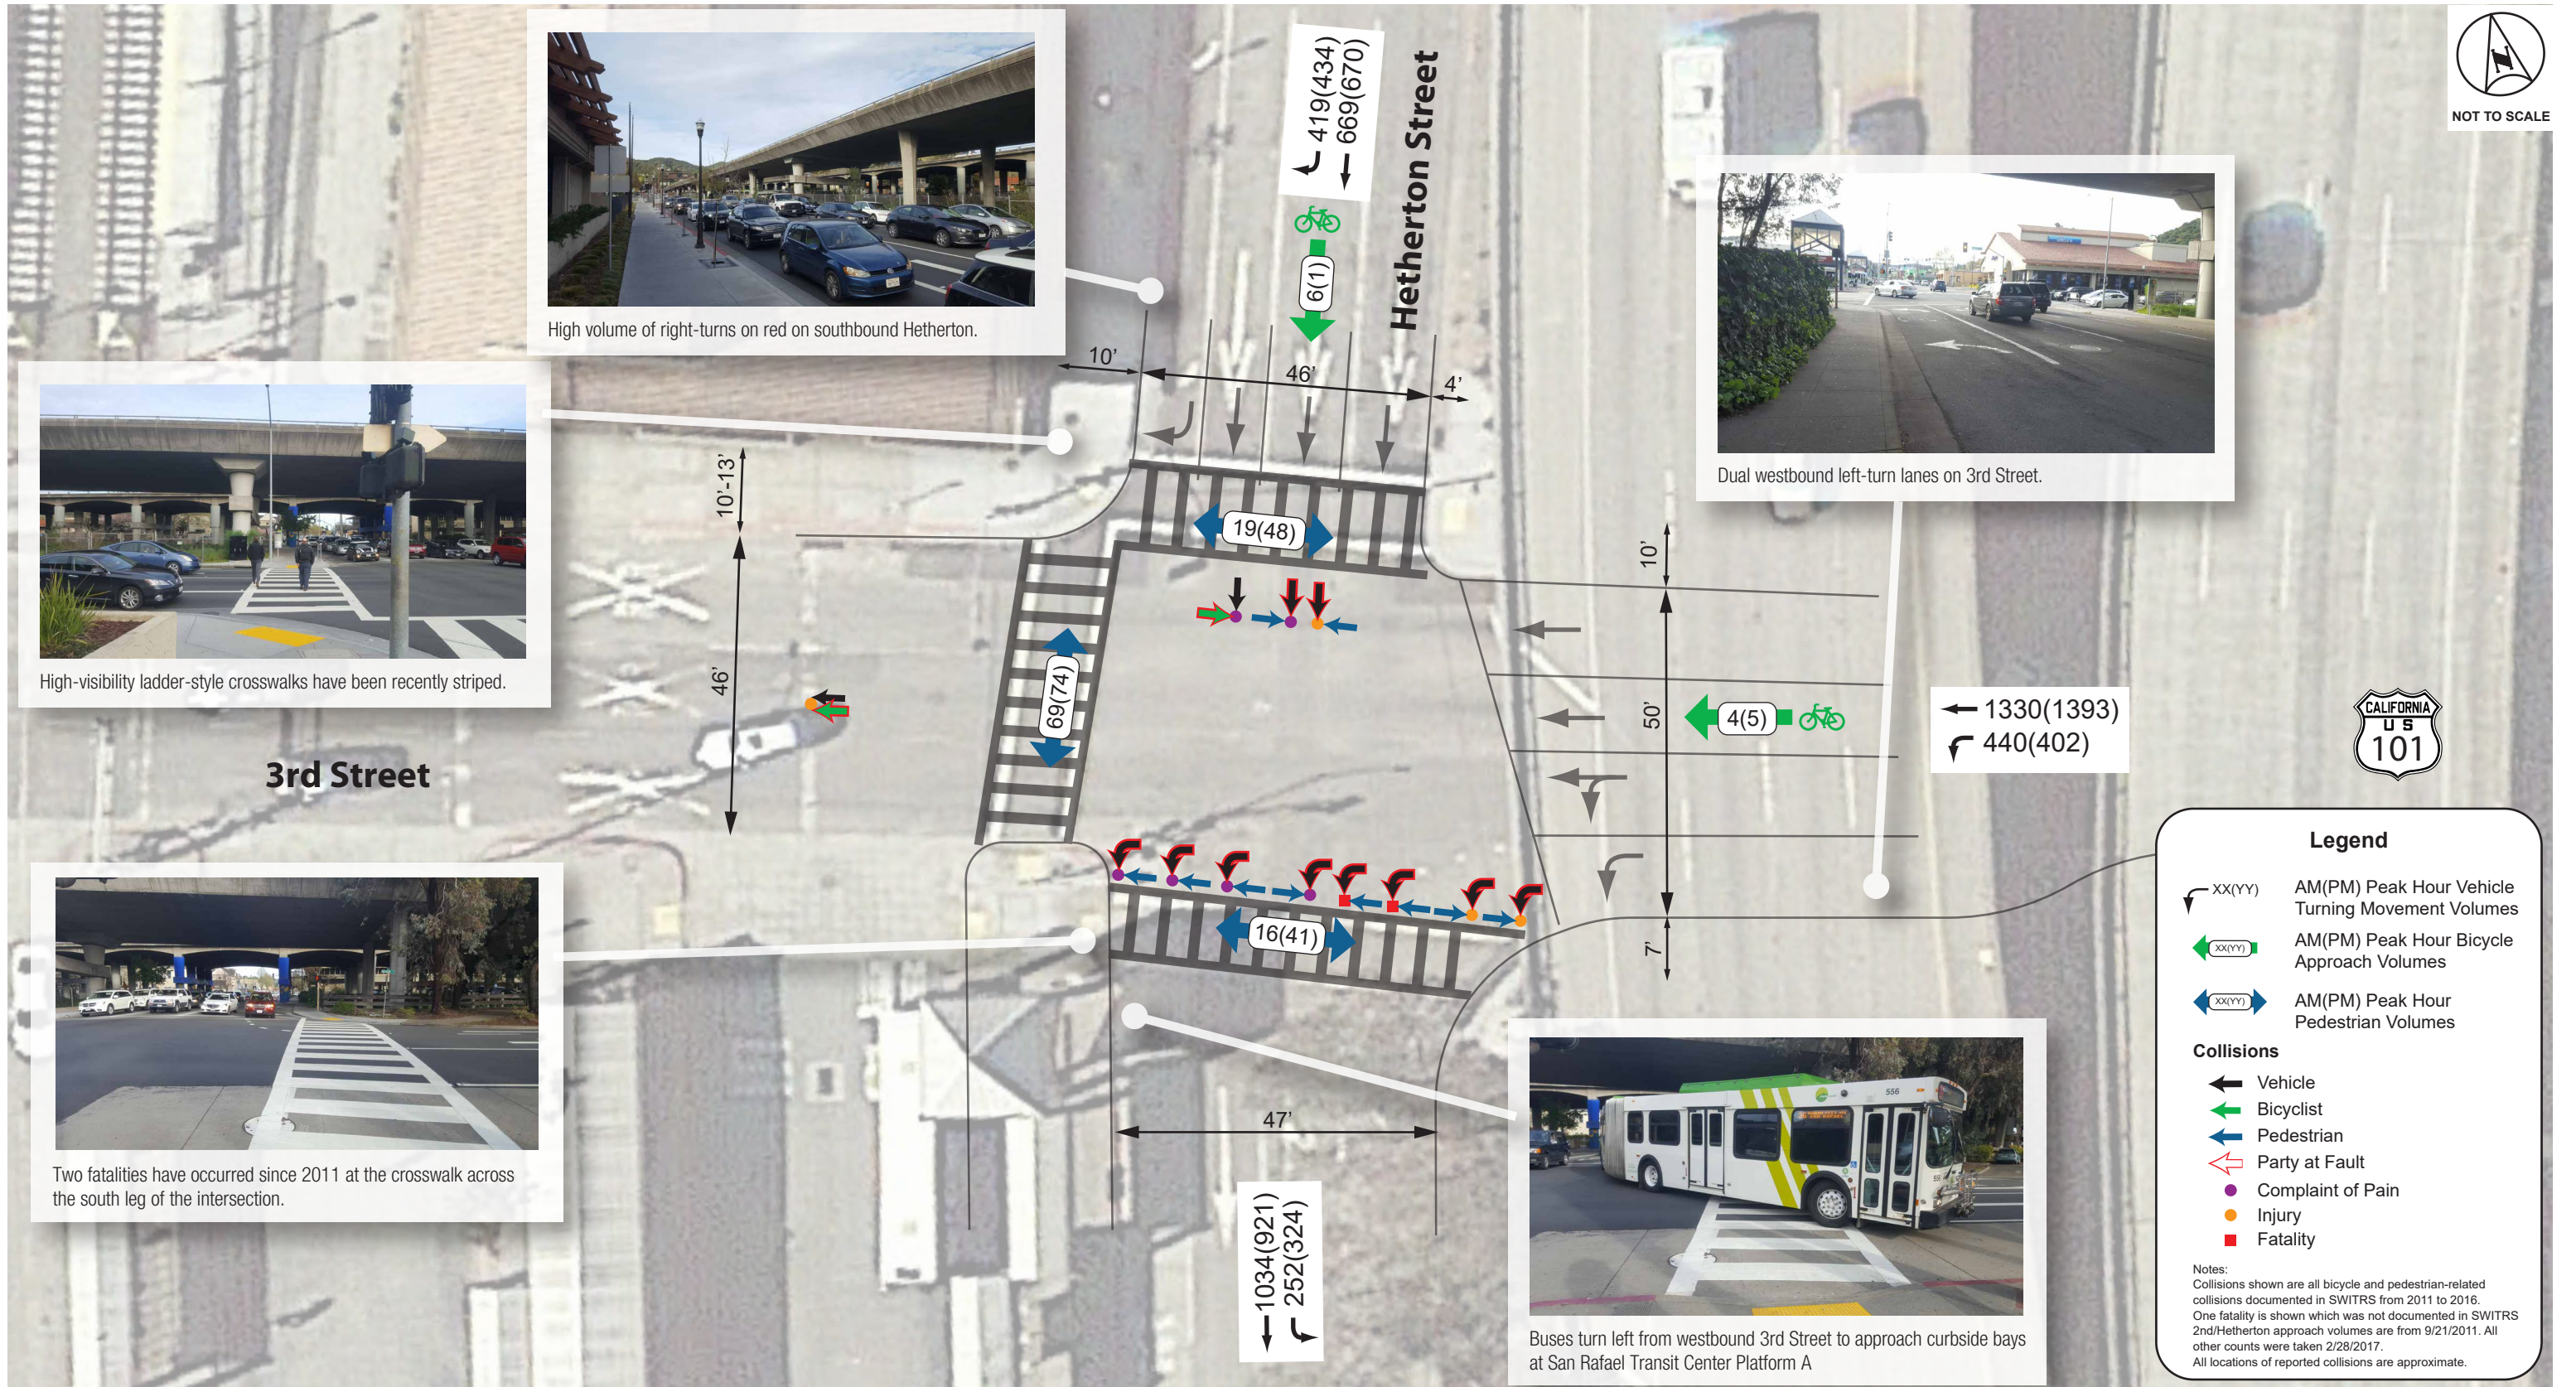
**Figure 2-1** depicts existing peak hour vehicle, bicycle, and pedestrian volumes at the intersection, as well as the history of bicycle and pedestrian-related collisions at the intersection from 2011 to 2016.

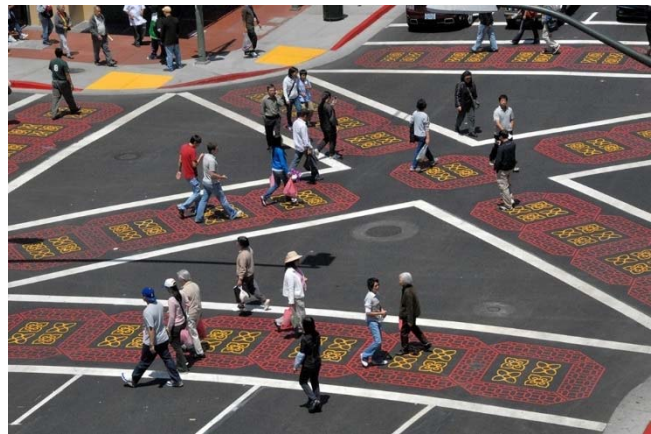
**Pedestrian Scramble (with existing geometry):** In analyzing this solution, the intersection was modeled assuming the minimum required 5 seconds “Walk” time and 26 seconds “Flashing Don’t Walk” time (governed by the NW-to-SE diagonal crossing distance). The intersection splits were then adjusted until the volume to capacity ratios (v/c ratio) of all vehicle movements were below 1.0. This exercise essentially determined the minimum required cycle length needed to accommodate the pedestrian scramble. In this

*Pedestrian scramble in Oakland Chinatown. Source: CommunityCommons.org*

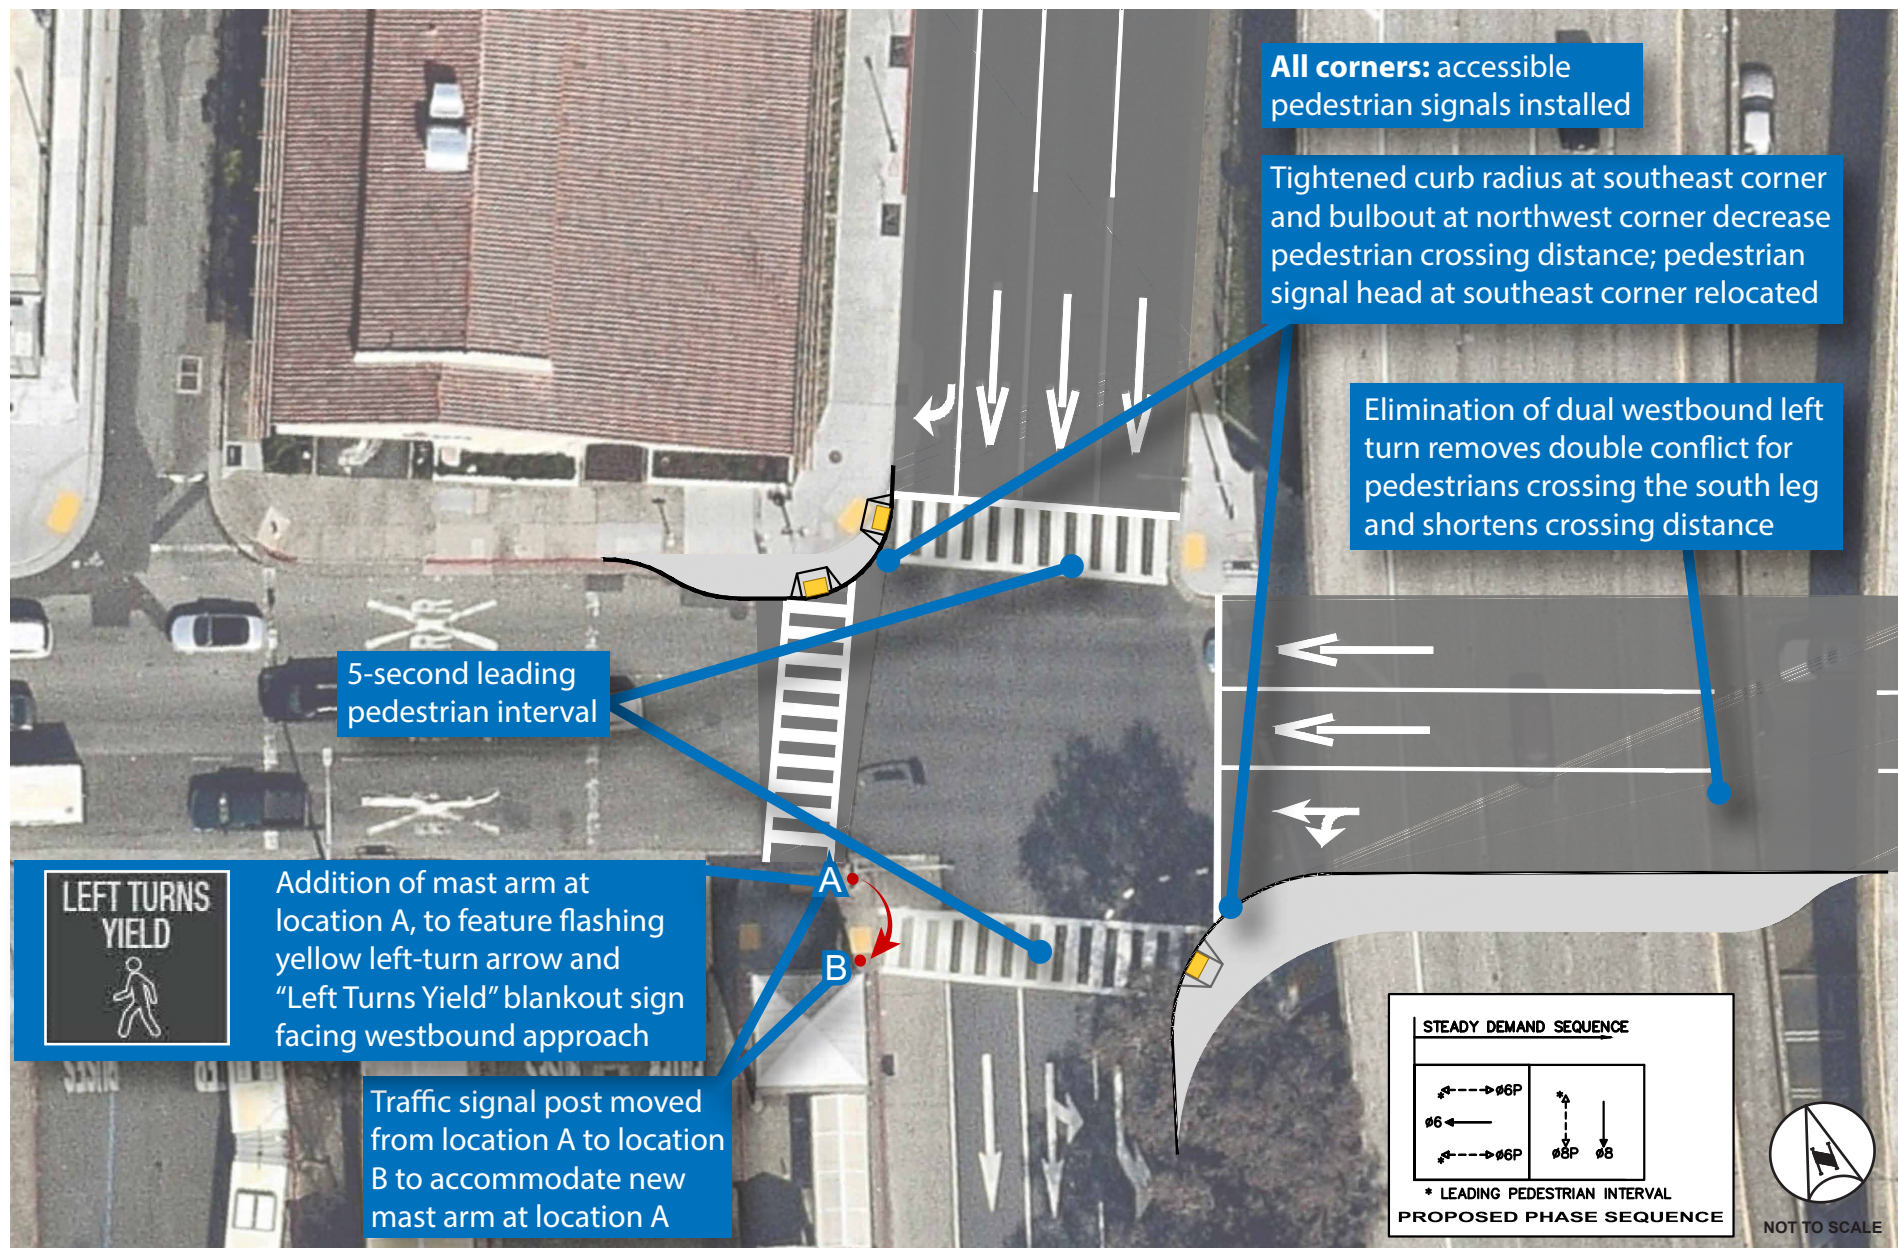
The recommended concept, as depicted in **Figure 3-1**, includes the following modifications:

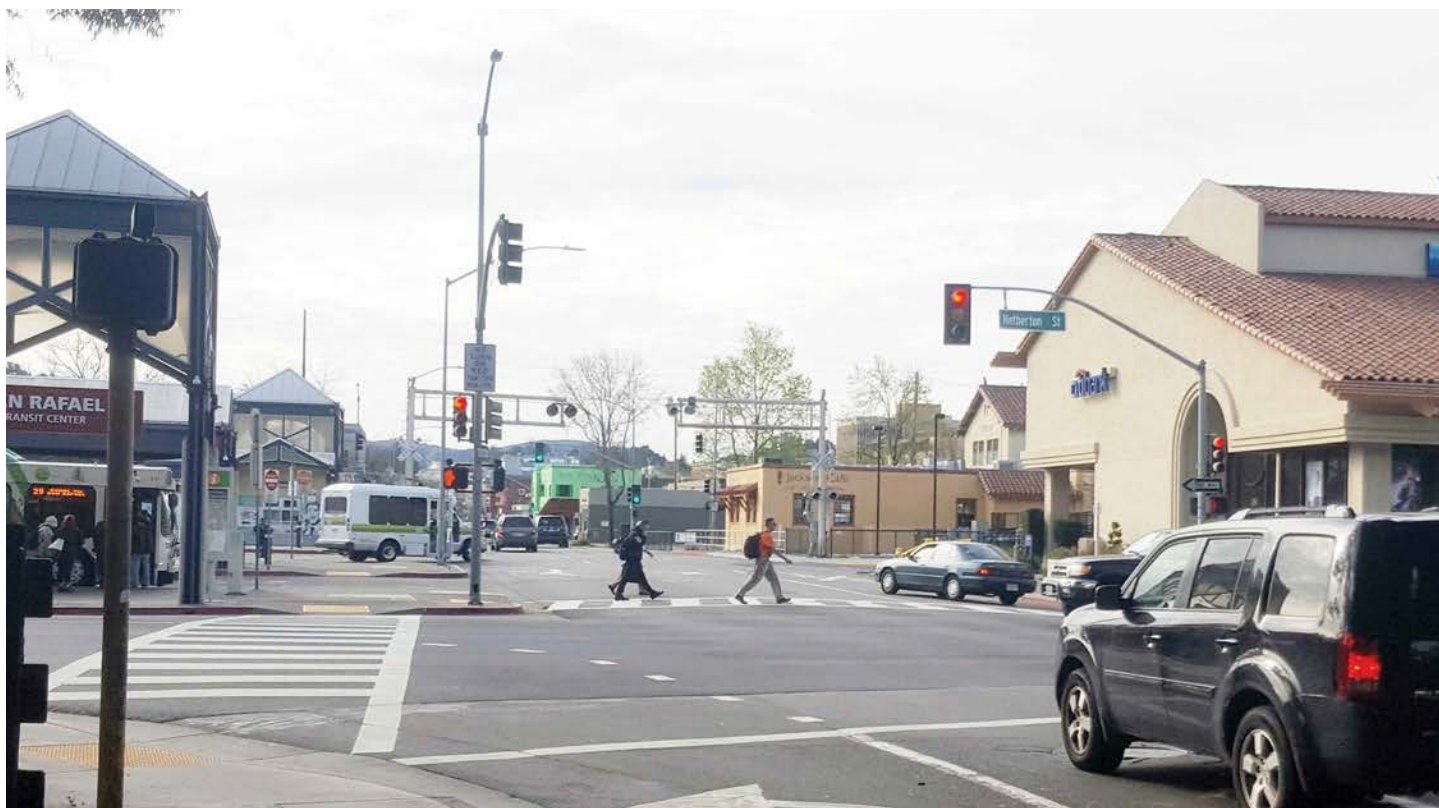
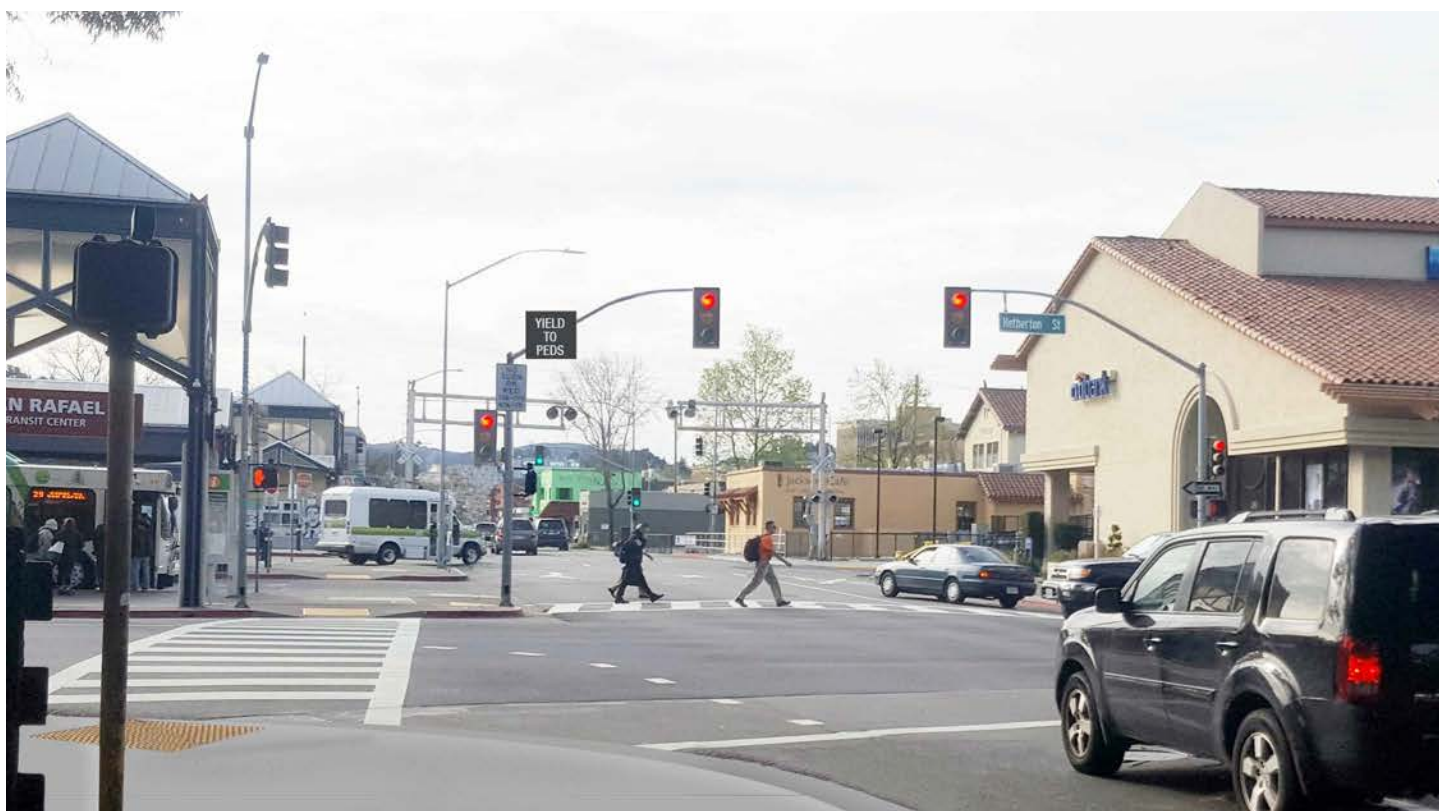
*Existing Conditions*

*With Improvements*

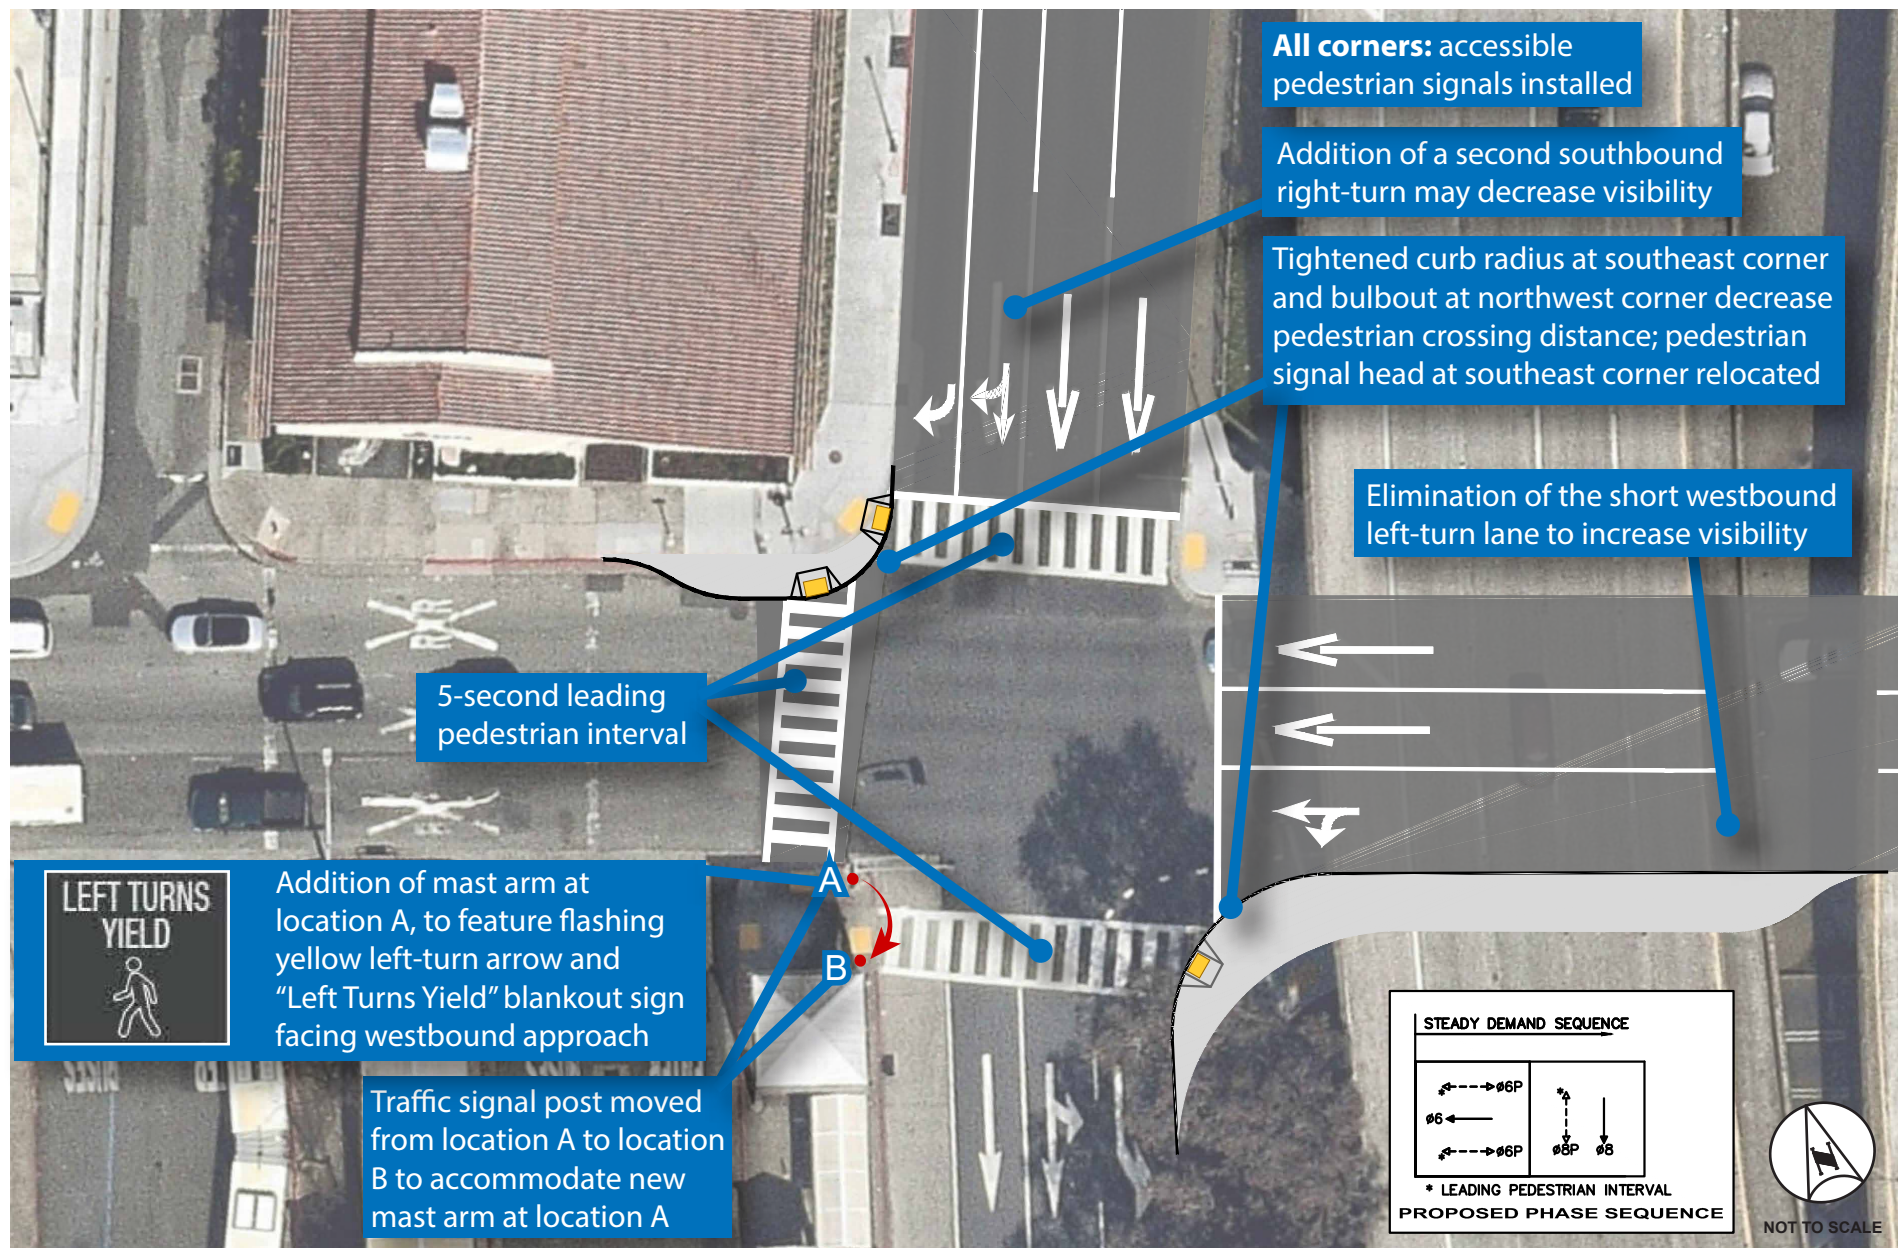
Eliminated Concept #2, as depicted in **Figure 3-5**, is an alternate version of the recommended concept. It is the same as the recommended concept in all aspects, except for those listed below:

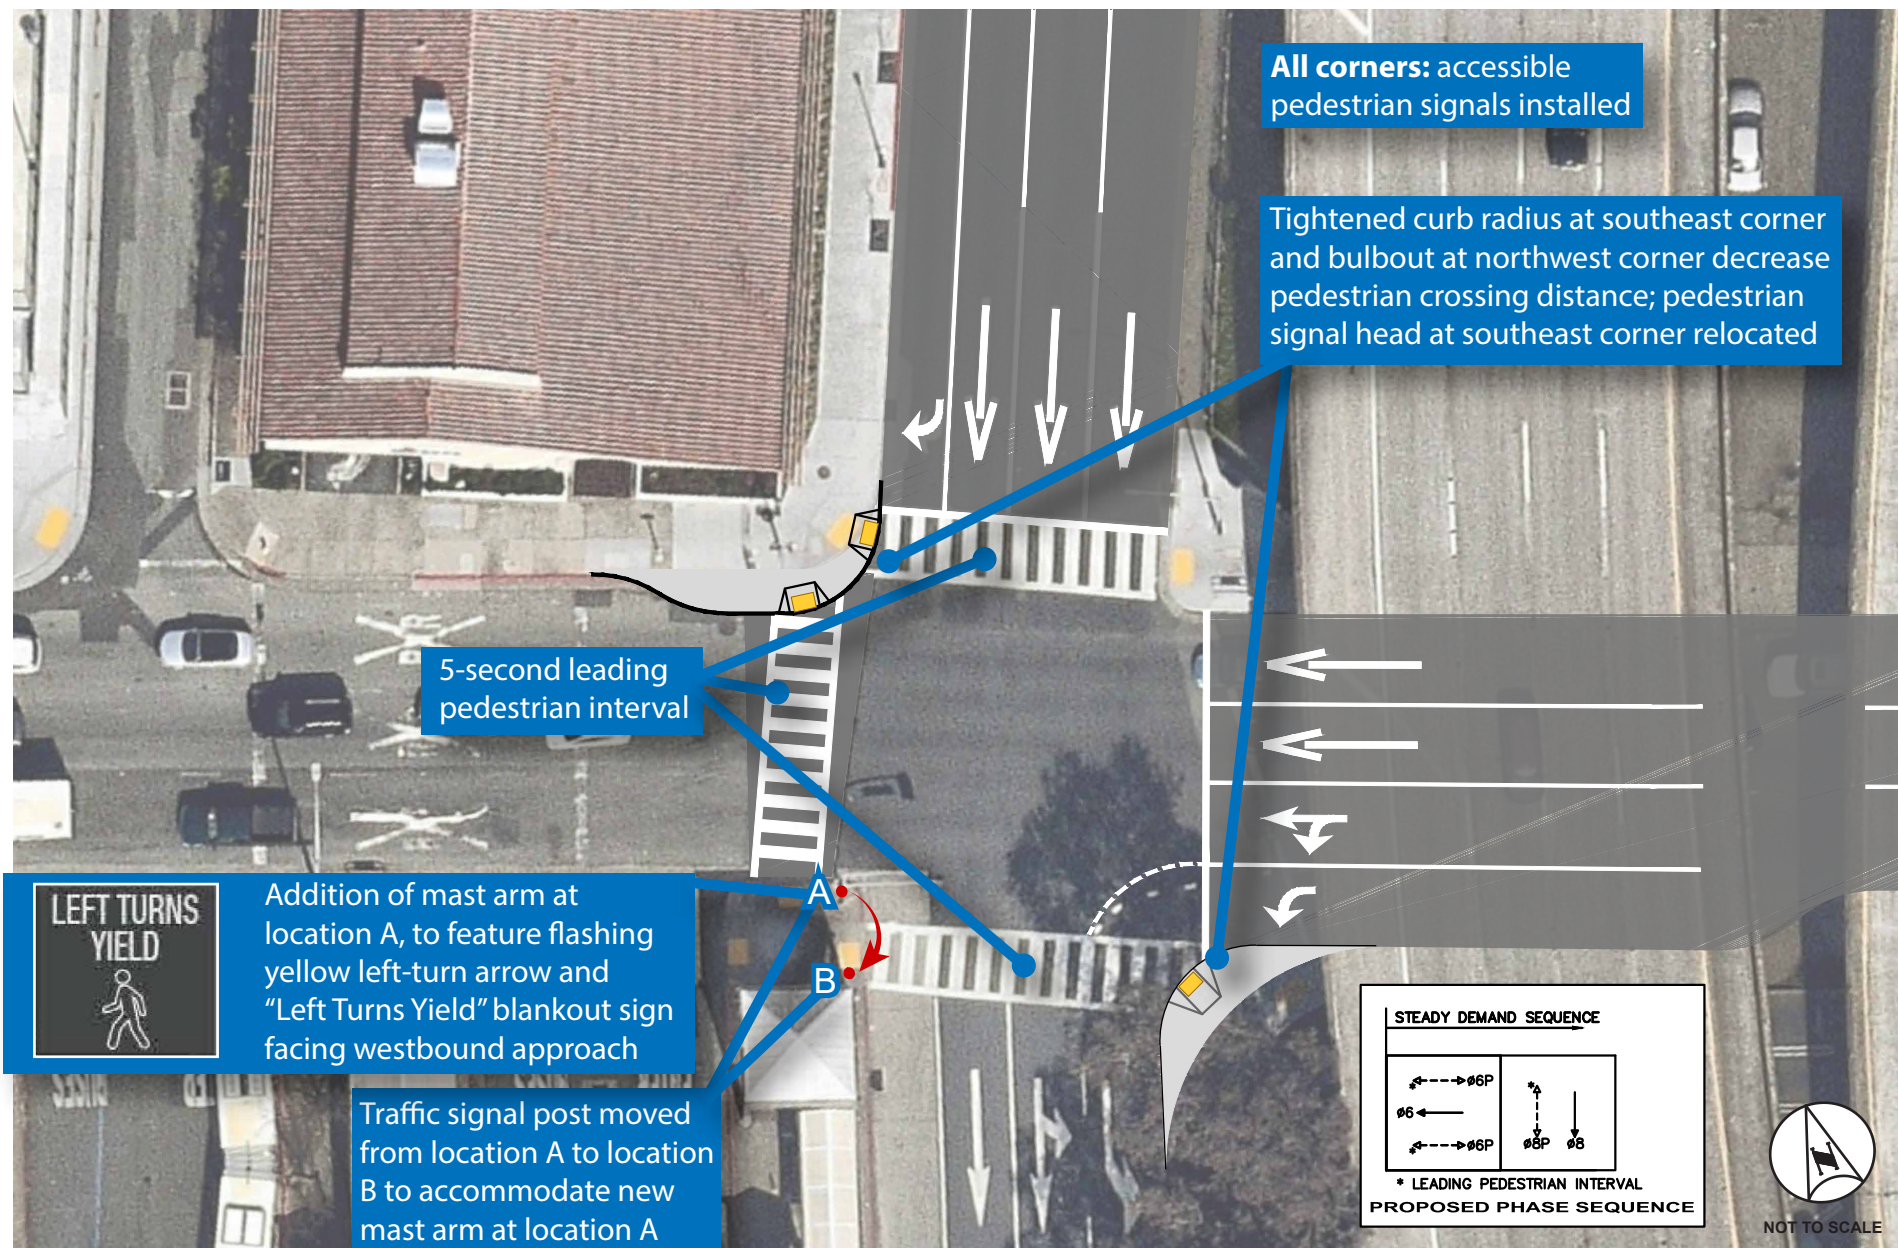
Eliminated Concept #3, as depicted in **Figure 3-7**, is another alternate version of the recommended concept. It is the same as the recommended concept in all of its treatments, except for those listed below.

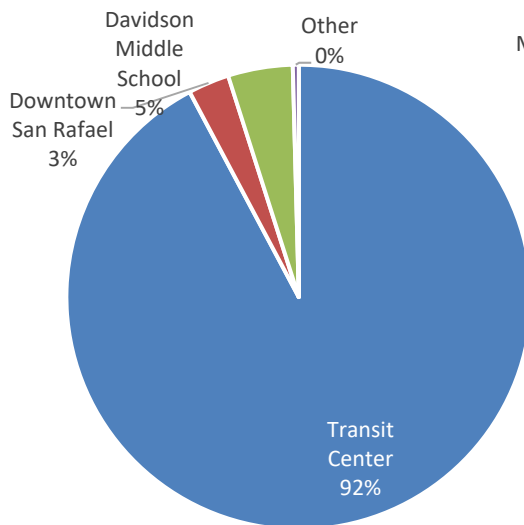
**Figure 4-1:** Intercept Survey Western Points of Origin/Destination

As evidenced by the survey results, the major pedestrian flow through the south leg crosswalk is between the transit center and San Rafael High School. This flow would be rerouted through the west and north leg crosswalks if the south leg crosswalk were removed. This would eliminate pedestrian-vehicle conflicts at the south leg, but would
